**A to Z Inspections
2721 NW 42nd Street
Oklahoma City, Oklahoma 73112
405-412-7861**

POLYBUTYLENE PLUMBING

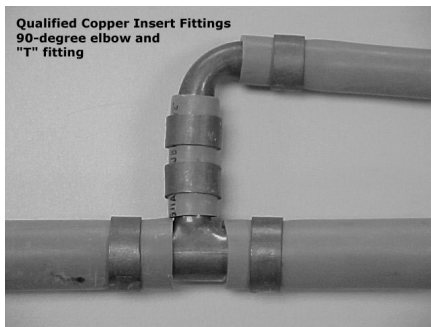
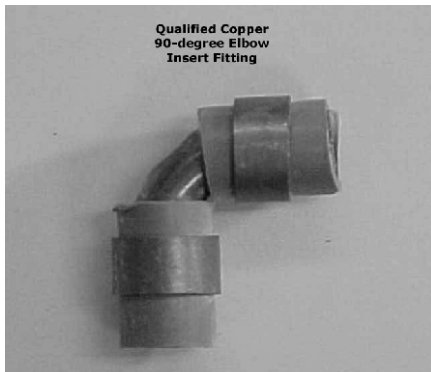
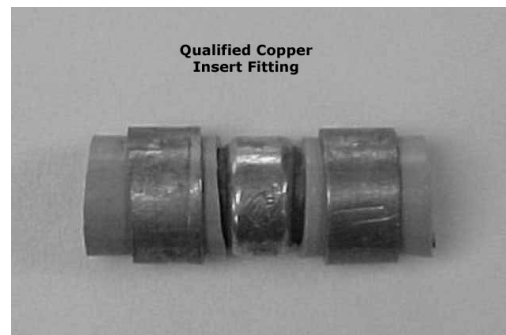
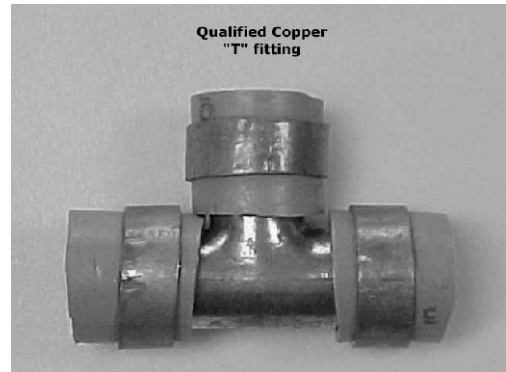
Polybutylene pipe (PB) is an easy to cut gray plastic that is put together with crimp connections. It was introduced in the late 1970's and it is still manufactured and used.

PB manufacturers have addressed joint problems with the "manablock" system and by joining pipes with a copper tube secured by two crimped copper bands.
